# DOUBLING DOWN

An innovative approach  
to repairs more than doubles the life  
of a seemingly-doomed parking structure.

By Eric VanDuyne and John Vincent

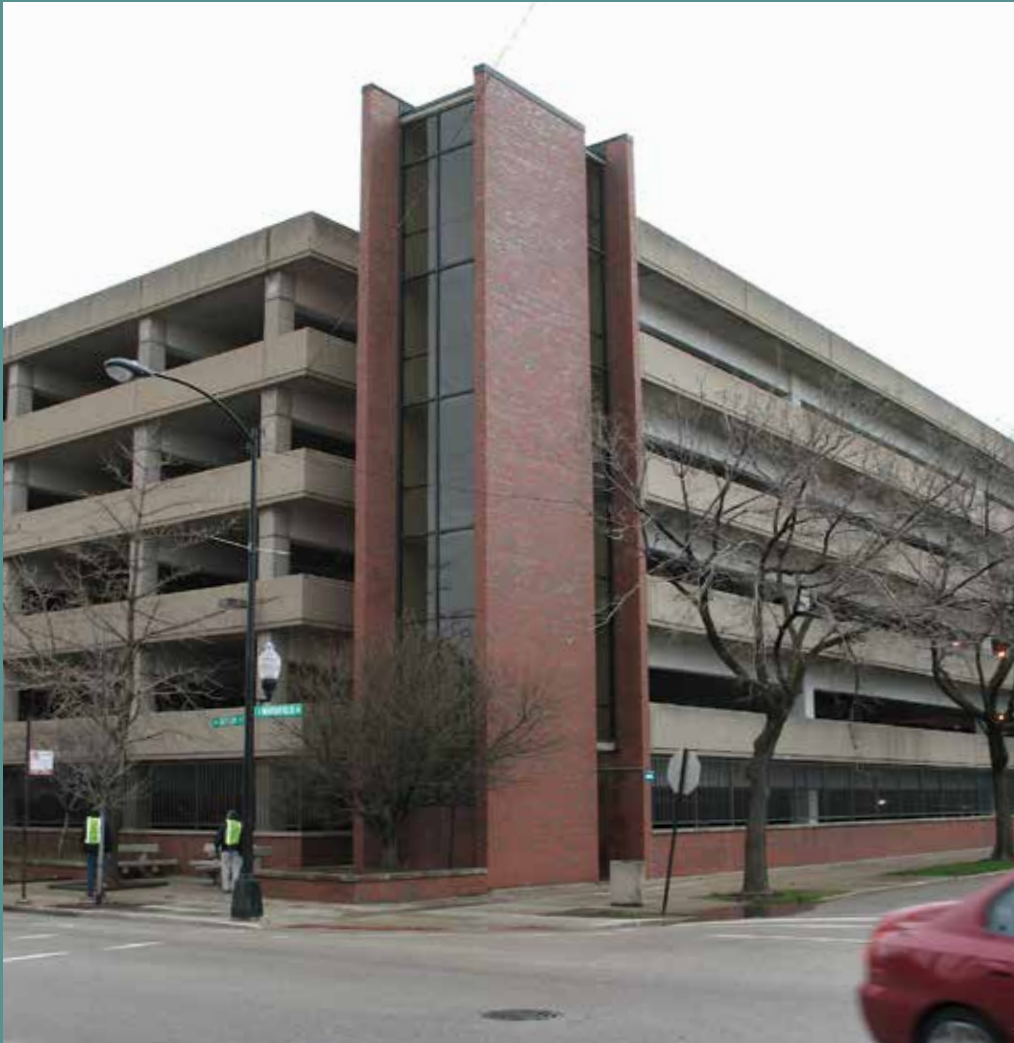
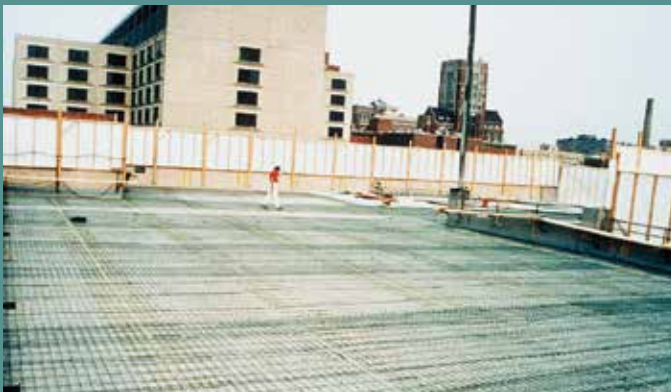
This five-level parking structure exhibited severe damage in 1991, after at least one failed attempt at repairs. A multi-pronged rehabilitation process was developed to repair damage and prevent future deterioration, and the garage is still in operation and in good condition more than 20 years later.
