FORWARD THINKING

How one county rehabilitated a deteriorating garage to expedite construction, save money, and minimize headaches along the way.

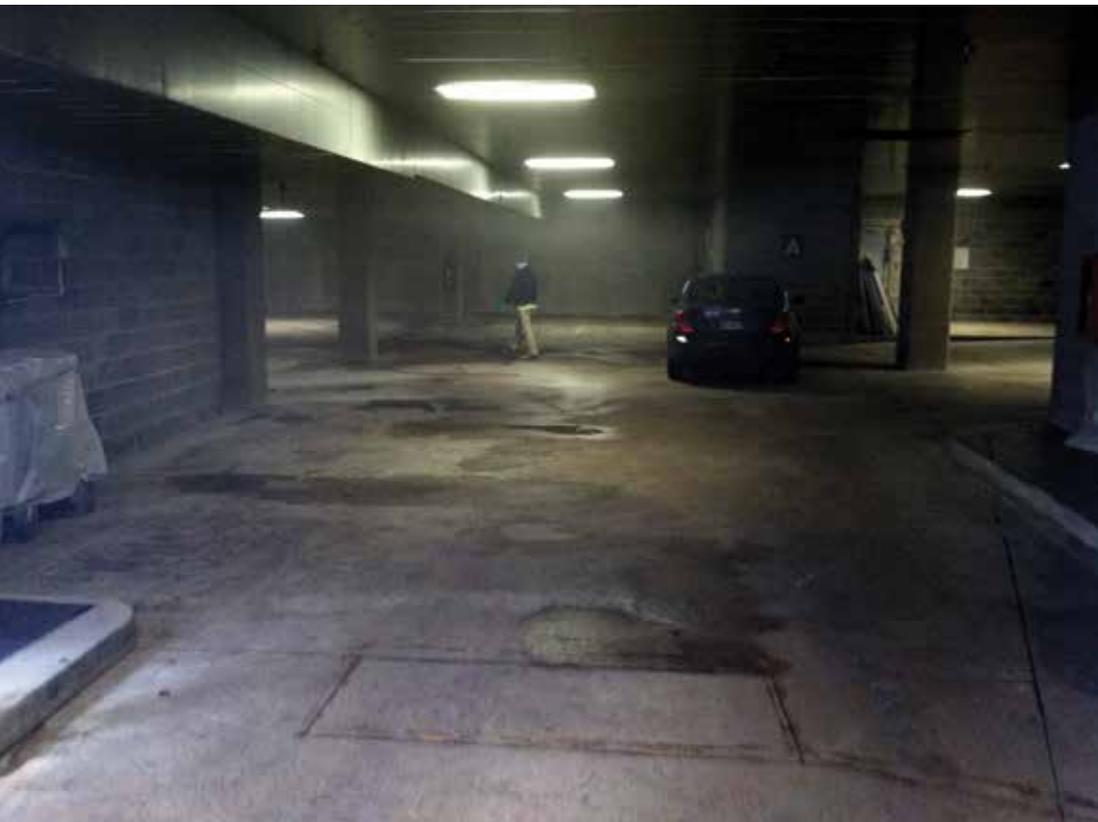
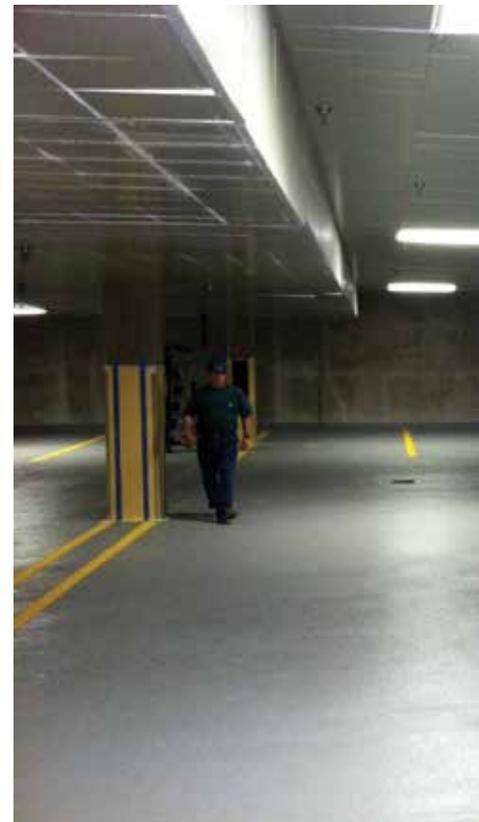
Extensive investigative work resulted in the finding that significant structural improvements would be necessary to stop the garage's deterioration and repair damage already done. The initial assessment uncovered cracking on the top surface of the concrete beams that had resulted in overstressing of the beams and exces-

sive deflection of the structure. The first priority, then, would be to strengthen these beams. Finding the cracks wasn't all bad as it turned out—their discovery spurred the county to retain a garage restoration specialist, and they were eventually found to be symptoms of many of the issues later discovered during the garage assessment.

Excessive cracking of the concrete surface had led to the accelerated deterioration of embedded structural reinforcement, and ultimately excessive deflection and spalling (chipping, flaking, and scaling) of the concrete. The surface cracking created a direct pathway to the structure's embedded reinforcement for salts/chlorides to penetrate. To holistically repair the parking garage and ensure the repairs would stand the test of time, it would be necessary to prevent salts/chlorides from getting in and doing even more damage.

The project included reviewing various options with the county to determine the most cost effective long-term maintenance plan to address salt/chloride penetration in the concrete surface. Ultimately, the county decided to follow the recommendation to install a traffic deck membrane on the entire supported floor surface. While initial costs would be higher with the application of a traffic deck membrane than with a traditional silane sealer application, the long-term costs when considering slab replacement and/or demolition that would be necessary for the sealer option or continued apathy would be significantly less.
